RE: Lead contamination in Room 114 and Room 112, Reed Gym (former firing range)

This letter is to document concerns about lead contamination in Reed Gym following a site visit by staff from the Idaho Department of Health and Welfare, Division of Public Health, Bureau of Community and Environmental Health (BCEH) on May 18, 2011. This visit was coordinated with ISU Facilities Operations and the Idaho Department of Environmental Quality (IDEQ).

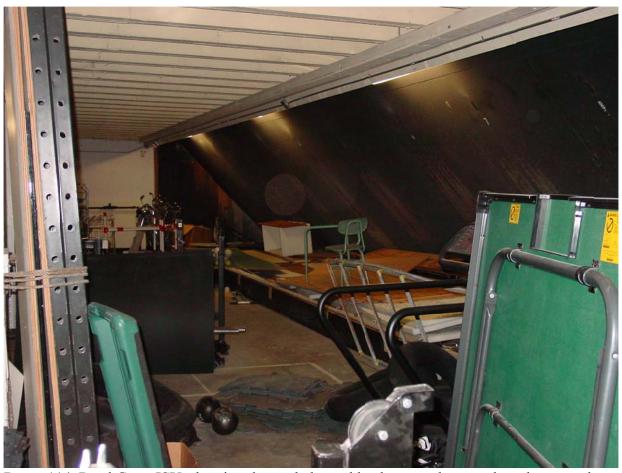
Preliminary hand held x-ray fluorescence (XRF) readings showed lead levels throughout Room 114 were consistently very high on floors and in floor cracks, on top of light fixtures, and on the bullet-deflecting metal backstop plate. XRF readings in Room 112 showed high lead levels only on top of the ductwork and light fixture. XRF serves as a good screening tool by providing real-time readings, but wipe sampling is preferred for quantification of lead in dust.

There is no duct work in Room 114, so we are not concerned about movement of lead dust via ducts beyond Room 114. In Room 114, thirteen out of the fifteen samples taken exceeded the 250 $\mu g/$ ft² clearance level. Those sampled items with hard surfaces (furniture) that were close to the clearance level could likely be thoroughly wet wiped to bring them below 250 $\mu g/$ ft² and be salvaged for use outside the room. Again, proper PPE should be worn. Those two items that are below the 250 $\mu g/$ ft² clearance level should also be HEPA vacuumed or wet wiped to remove dust before re-use since one wipe sample may not be representative of the lead dust loading on the entire surface of the item. Those porous items higher than 250 $\mu g/$ ft² of lead should be properly disposed of. For example, sample ID #15 (a tarp with lead dust concentration of 1300 $\mu g/$ ft²) should be disposed of rather than cleaned. Any item that is not easily wiped clean using a wet method should also be disposed of. The metal backstop plate and the sand trap in Room 114 will need to be removed or encapsulated in place by an EPA-approved lead remediation contractor. It is possible that overlay/encapsulation will be necessary for the floor in Room 114 as well. Any disposal should be coordinated with IDEQ's hazardous waste staff.

Room 114, Reed Gym, ISU, showing the angled metal backstop and covered sand trap on the right side of the photo. Photo taken on 5/18/2011. Lead wipe samples were highest on the floor in front of the trap (center of the photo) and on the overhead light fixture diffuser plates.

- Room 114 should remain locked. A tacky mat should be placed just inside the entrance to remove lead dust from shoes of workers when exiting the room. Lead can easily be tracked out of this room and contaminate other areas. Inhalation of lead dust is also a real health risk if work or other activities in the room suspend the fine dust found throughout the room.

- Signage on both sides of the door into Room 114. The exterior sign should clearly note that a lead dust hazard exists and entry is restricted. The interior sign should note that no objects are to be removed from Room 114 without first consulting ISU Facilities Operations to coordinate proper disposal or proper cleaning.

- None of the stored items in Room 114 should be allowed to leave the room unless properly cleaned first or bagged for disposal.
- Room 114 should be remediated by a professional lead abatement contractor as soon as possible.
